Manhole Inspection Summary

Manhole # S17QQ1002MH

Insp Date: **2/21/07 11:11 AM**

Location Address: **SPRINGARDEN DR**

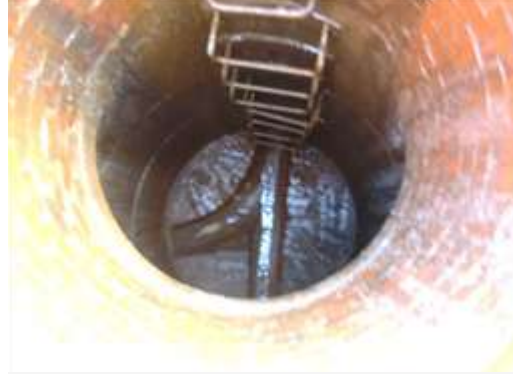
Top View

☒ **Debris** (not Condition related)

Bench and Channel debris.

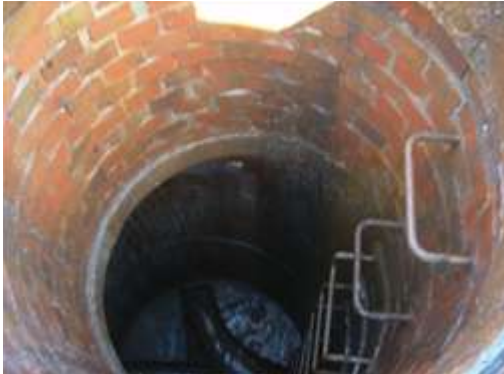
Defect

☒ **Leaks**

Condition: ☐ Sound ☐ Cracked ☐ Root Intrusion ☐ Loose Brick ☒ **Deteriorated**

Infiltration: ☐ None ☒ **Joint** ☐ Cracks ☐ Mortar ☐ Roots ☒ **Wall**

Infiltration: ☐ None ☐ Joint ☐ Cracks ☐ Mortar ☐ Roots ☒ **Wall**

Frame leaks. Adjustment deterioration and infiltration. Corbel and Barrel infiltration.

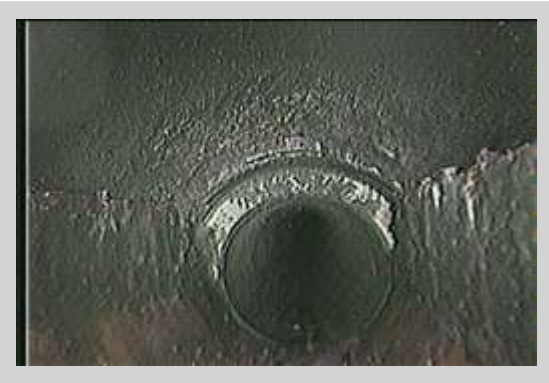
8 in. Circular Gravity Sewer Pipe Out @ 12 O'Clock

Invert Depth: **12.03** (ft.) Flow Characteristics: **Slow**

Deposits: ☒ None ☐ **Mud** ☐ Sludge ☐ **Debris** ☐ Grease

Infiltration: **None** Pipe Seal Cond: **Unknown**

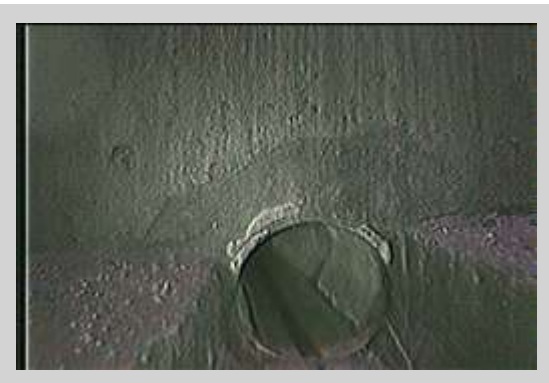
8 in. Circular Gravity Sewer Pipe In @ 6 O'Clock

Invert Depth: **11.81** (ft.) Flow Characteristics: **Slow**

Deposits: ☒ None ☐ **Mud** ☐ Sludge ☐ **Debris** ☐ Grease

Infiltration: **None** Pipe Seal Cond: **Unknown**

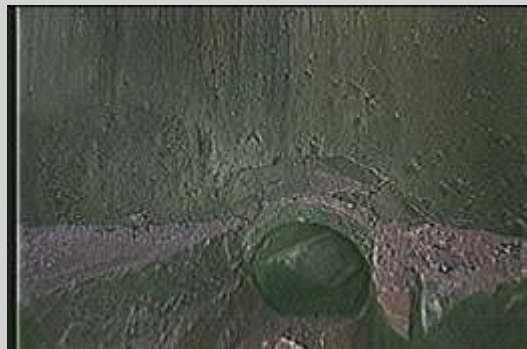
Pipe In @ 9 O'Clock

Deposits: ☐ None ☒ **Mud** ☐ Sludge ☒ **Debris** ☐ Grease

Silt Depth: **0.5** (in.)

Deposits Extent: **Light**

Connects To: **Dead End**
